PROSPECT ISLAND RESTORATION

Prospect Island Miner Slough Levee Inspection Report

Inspected on February 27, 2008

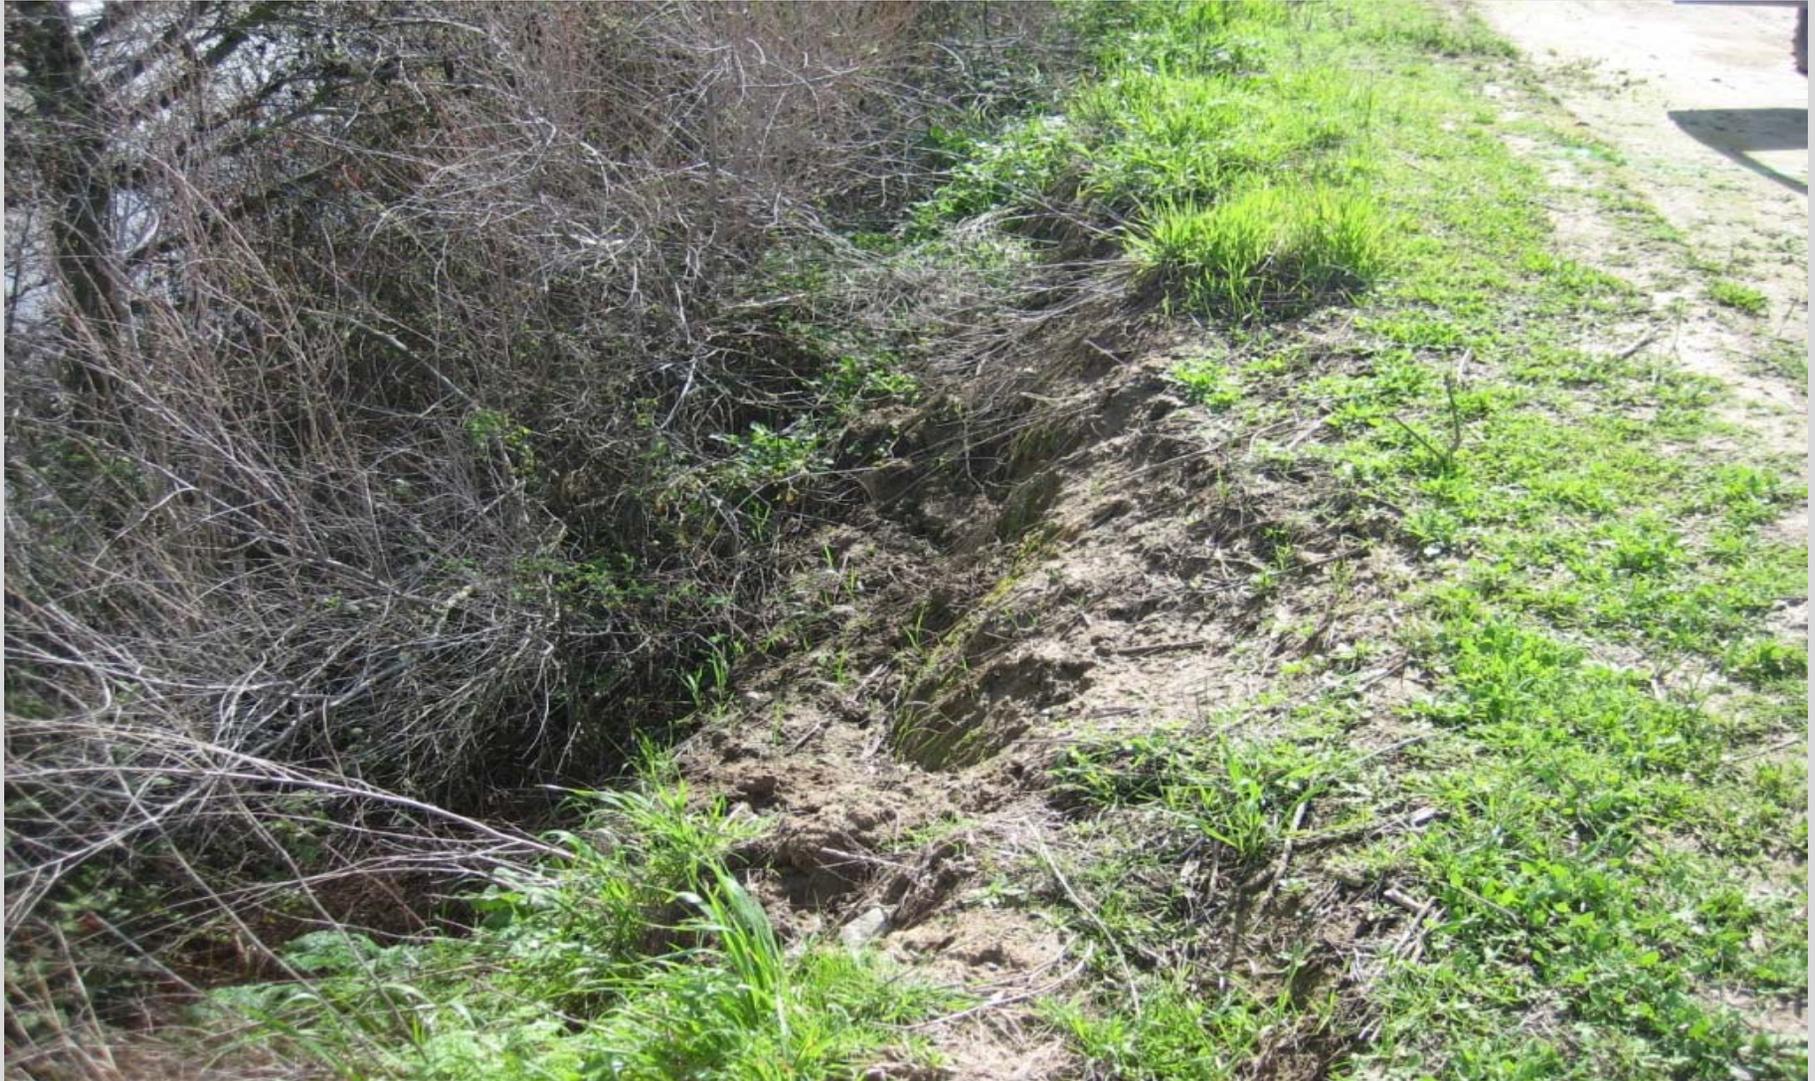
Station 95+65 – Sloughing on levee crest

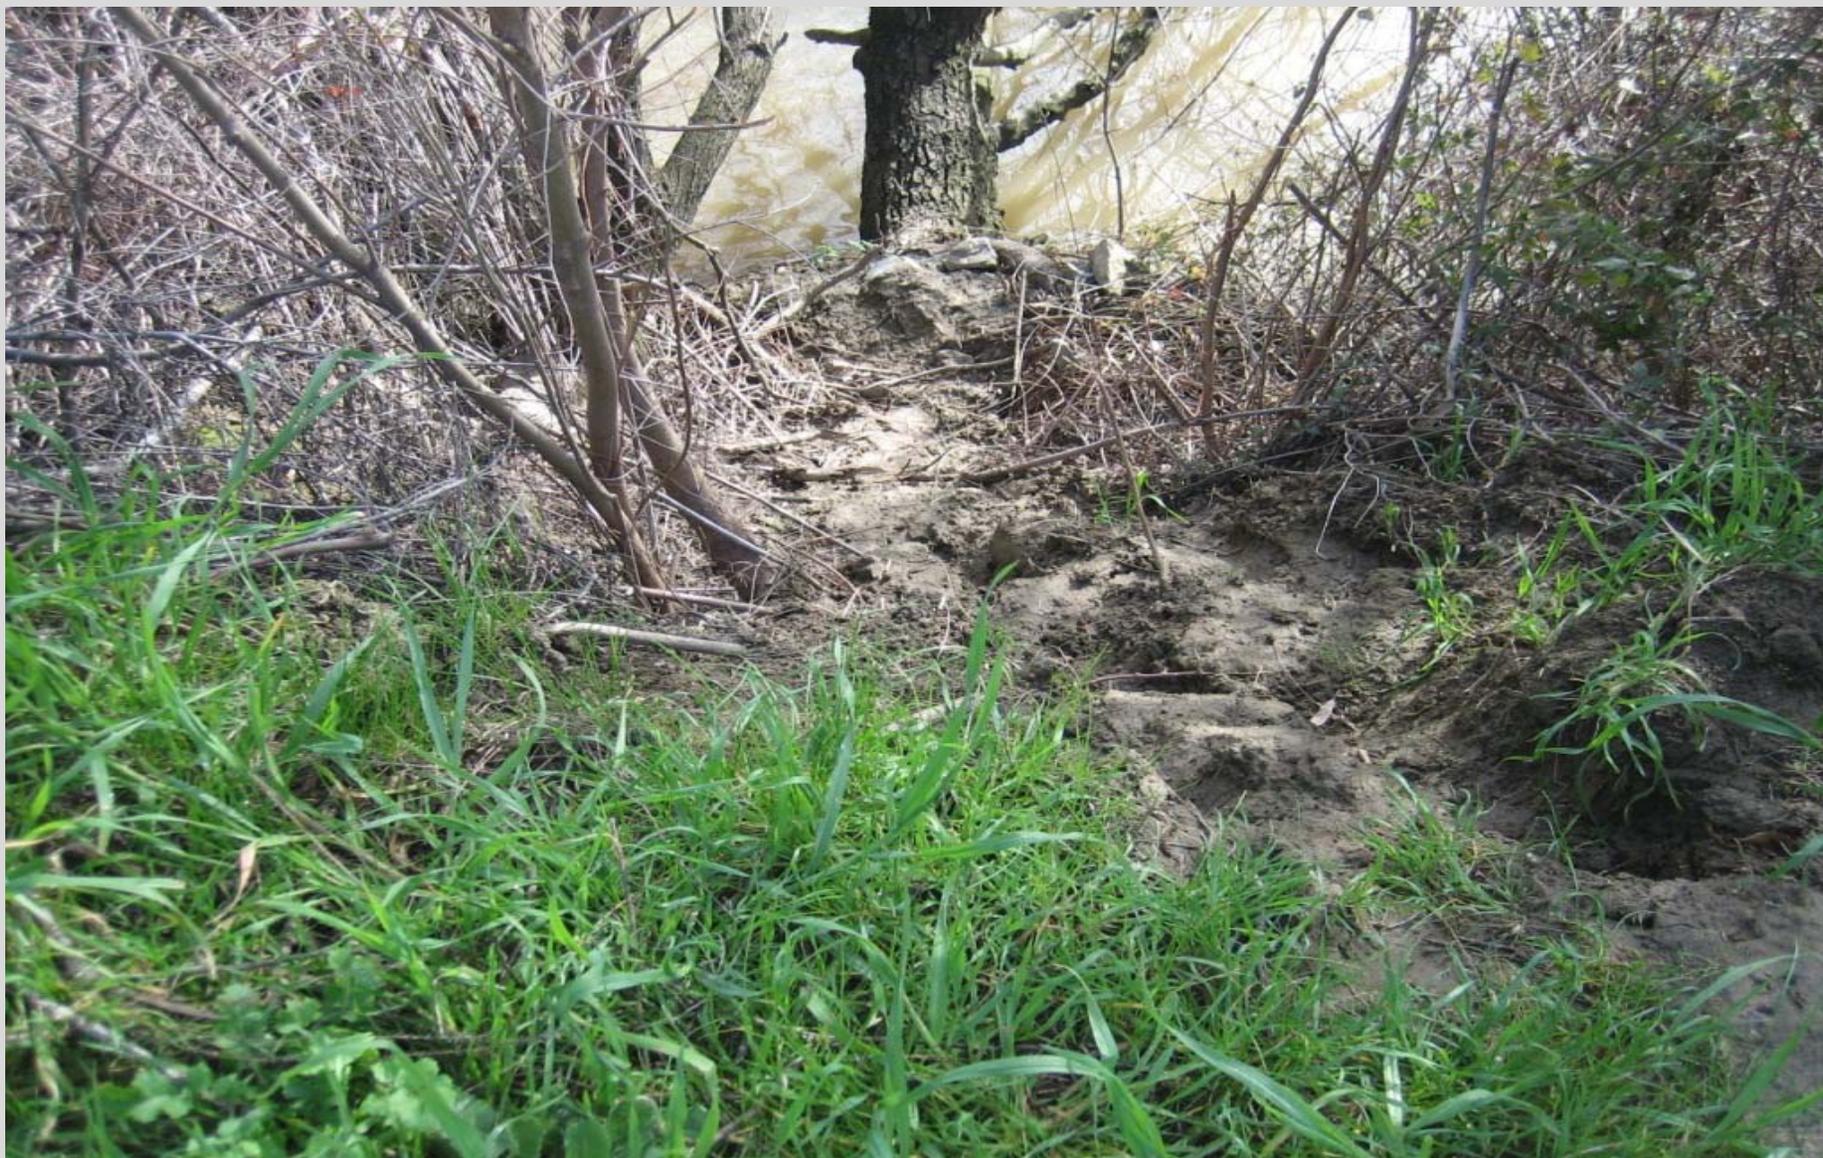
Station 62+50 – Sloughing at water's edge

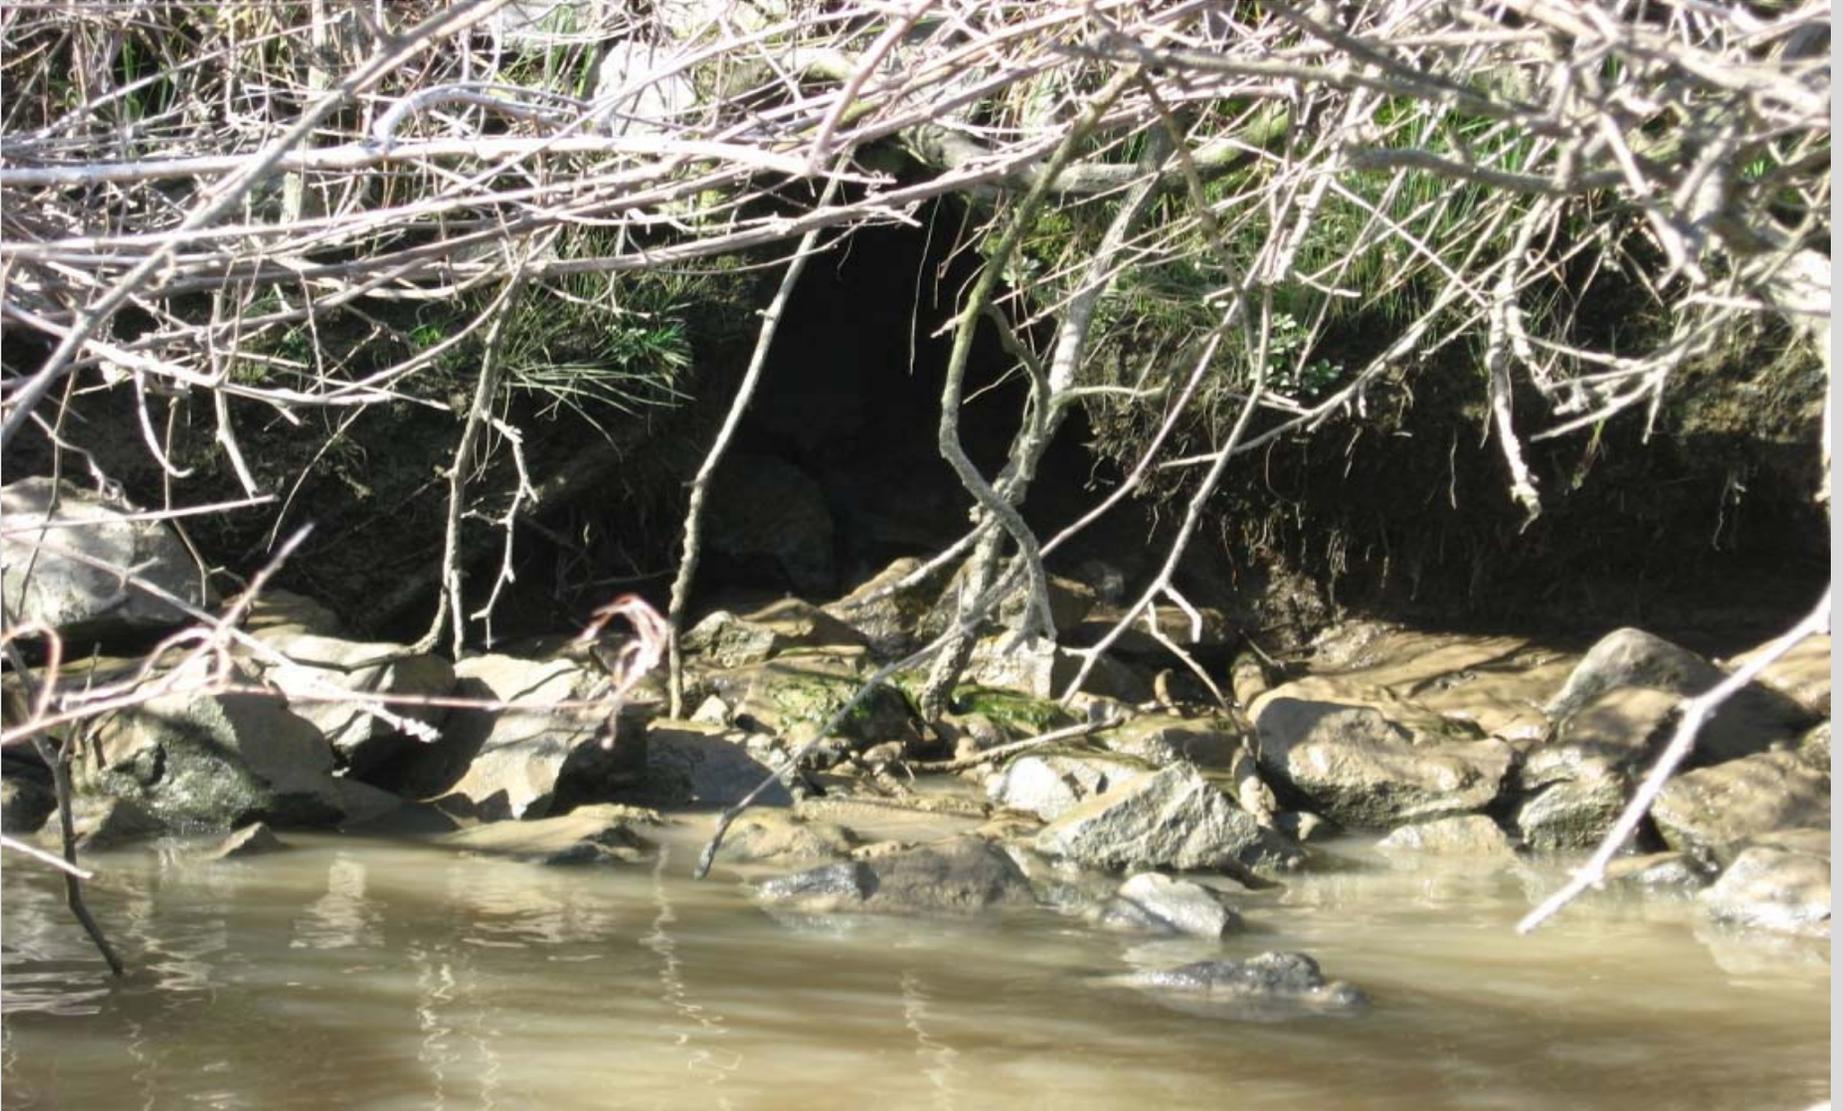
Priority 1 (Severe) – Station 120+00 – Steep slope with a hole over 9 feet deep:

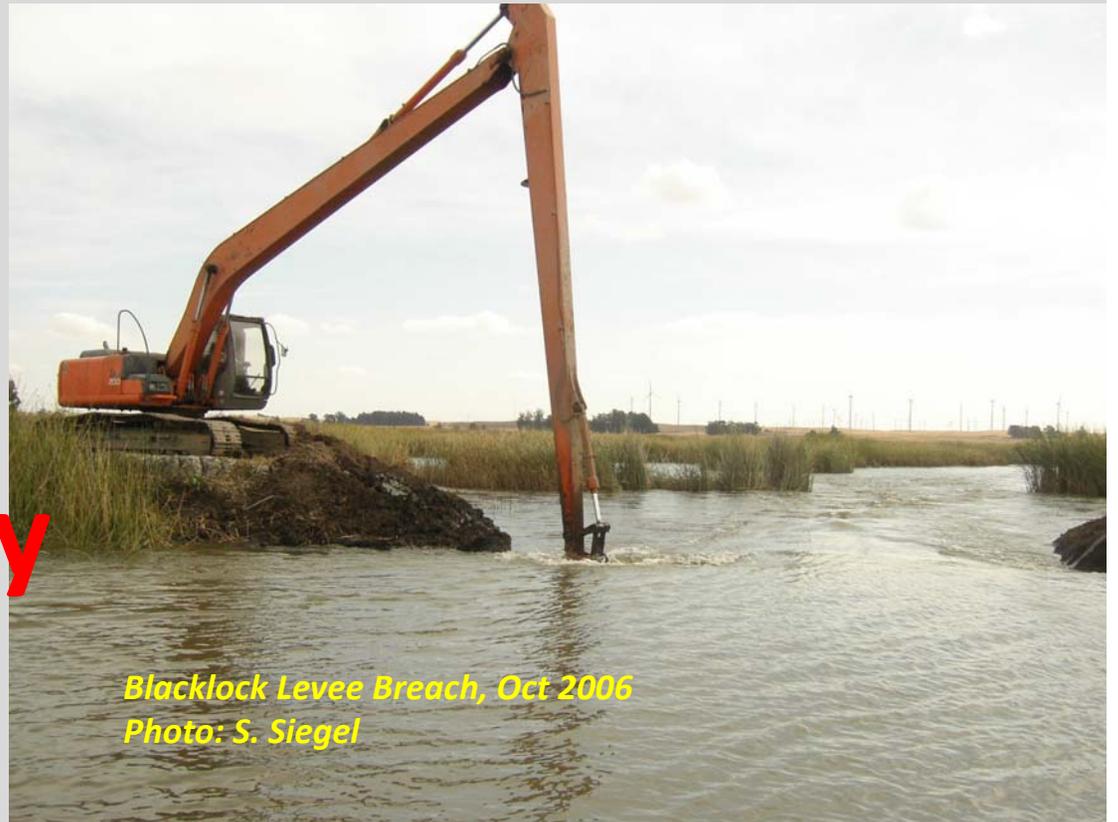
*Blacklock Levee Breach, Oct 2006
Photo: S. Siegel*
